# Improved Materials For High-Temperature Black Liquor Gasification

James R. Keiser\*, J. Peter Gorog\*\*, Roberta A. Peascoe\*,  
James G. Hemrick\*, and Camden R. Hubbard\*

\*Oak Ridge National Laboratory, Oak Ridge, TN

# History Of Commercial Black Liquor Gasifier Constructed At Mill In New Bern, NC

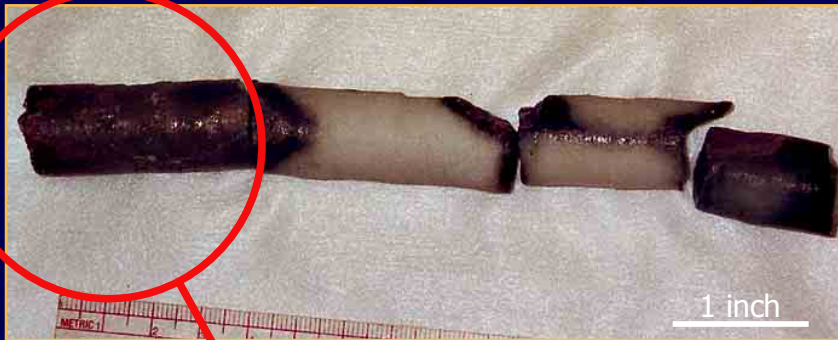
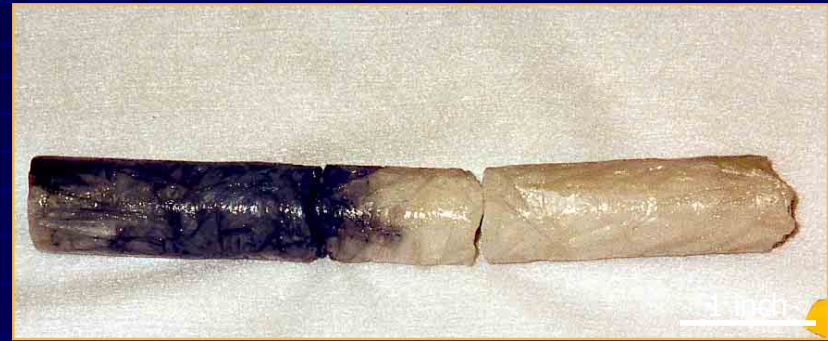
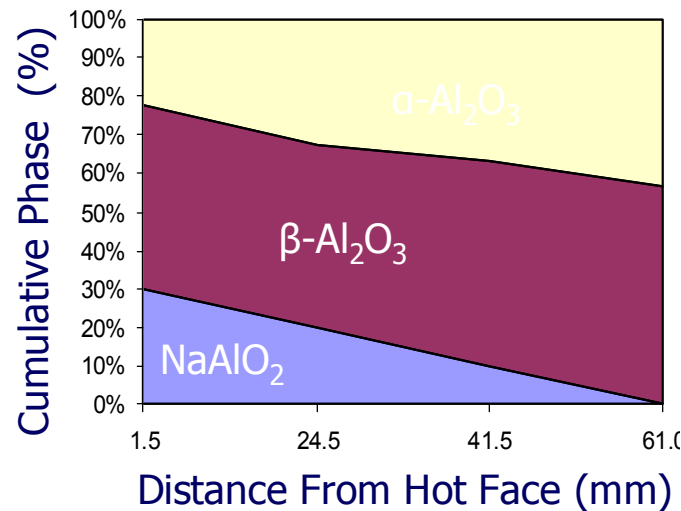
- ❖ NaAlO<sub>2</sub> found on hot face
- ❖ Increased Na content found at back of the working lining and front of backup lining
- ❖ No NaAlO<sub>2</sub> detected in backup lining

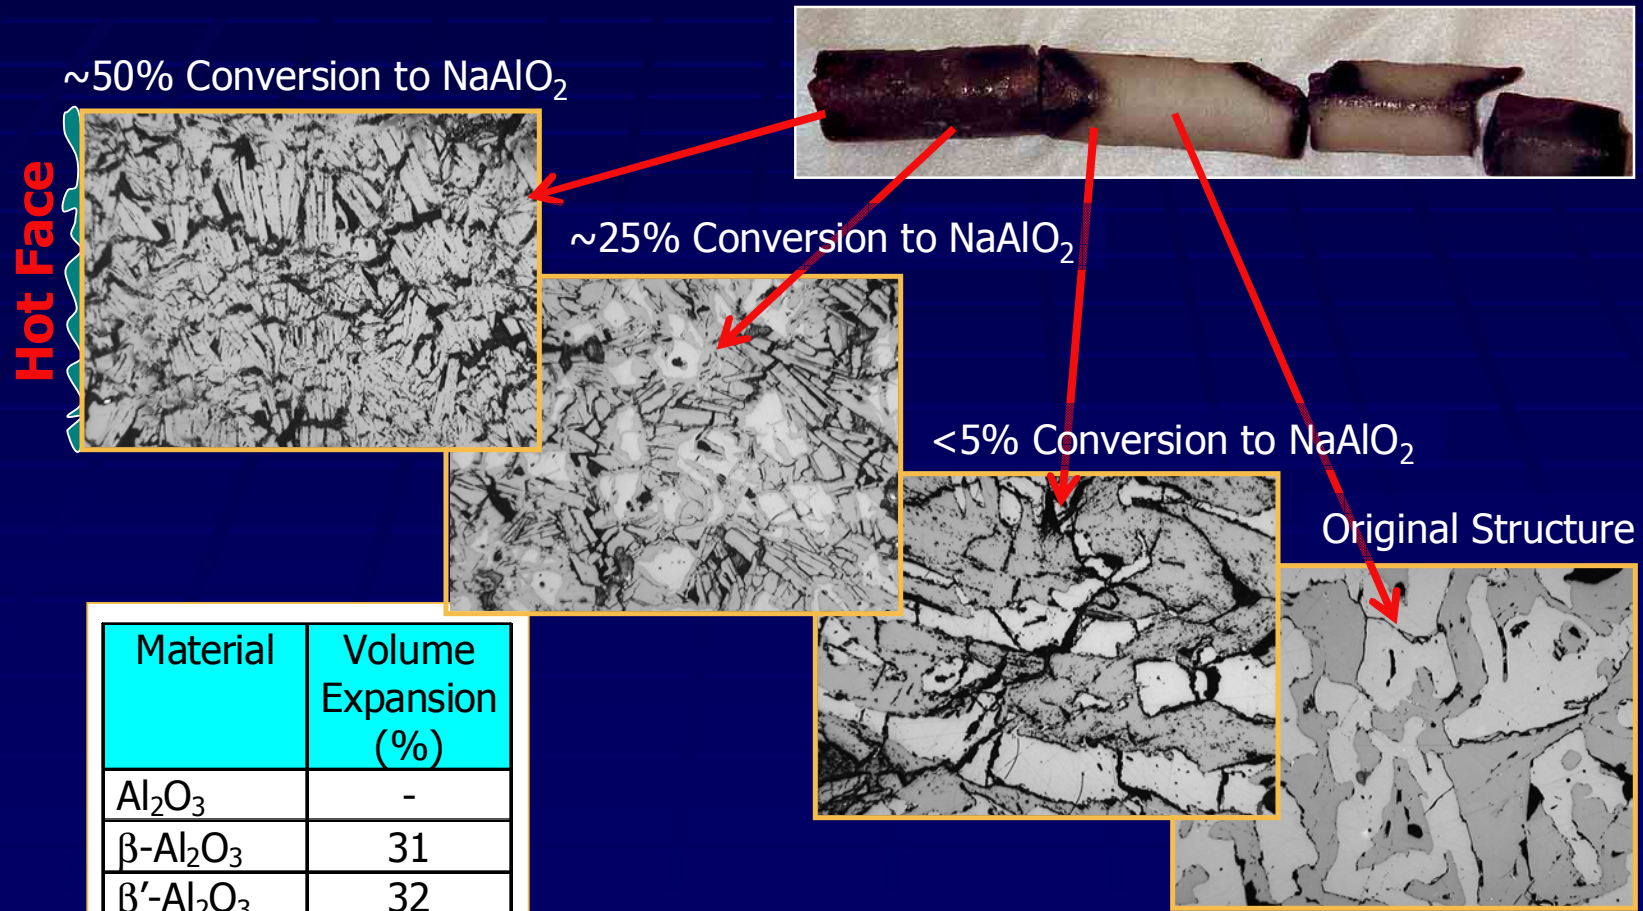
# Observed Microstructural Changes Resulted From Reaction With Sodium

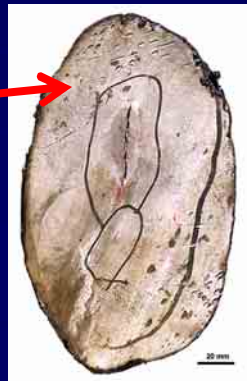
Through-wall crack on the shell was first indication seen by mill personnel

- ❖ Mill water used during installation likely contained chlorides which contaminated materials adjacent to the shell
- ❖ Water condensed on the inside of the shell during start ups and shut downs and dissolved the chlorides
- ❖ Cycling of the unit concentrated the chlorides on the shell surface
- ❖ The chemical expansion of the refractory lining caused high tensile hoop stress in the shell
- ❖ The presence of tensile stress and aqueous solution of chlorides caused Stress Corrosion Cracking (SCC) in the 316L shell
- ❖ Tensile stress introduced during operation caused some of the cracks to grow through the shell
- ❖ Above mechanism repeatedly occurred until the pressure vessel failed

- ❖ Hemispherical Dome
- ❖ Carbon steel refractory containment which is not susceptible to Cl- SCC
- ❖ Crushable metal foam used between refractory and shell
- ❖ Fused cast alumina working lining over high alumina backup lining
- ❖ Expansion allowance for growth of refractory based on data collected after one year of operation

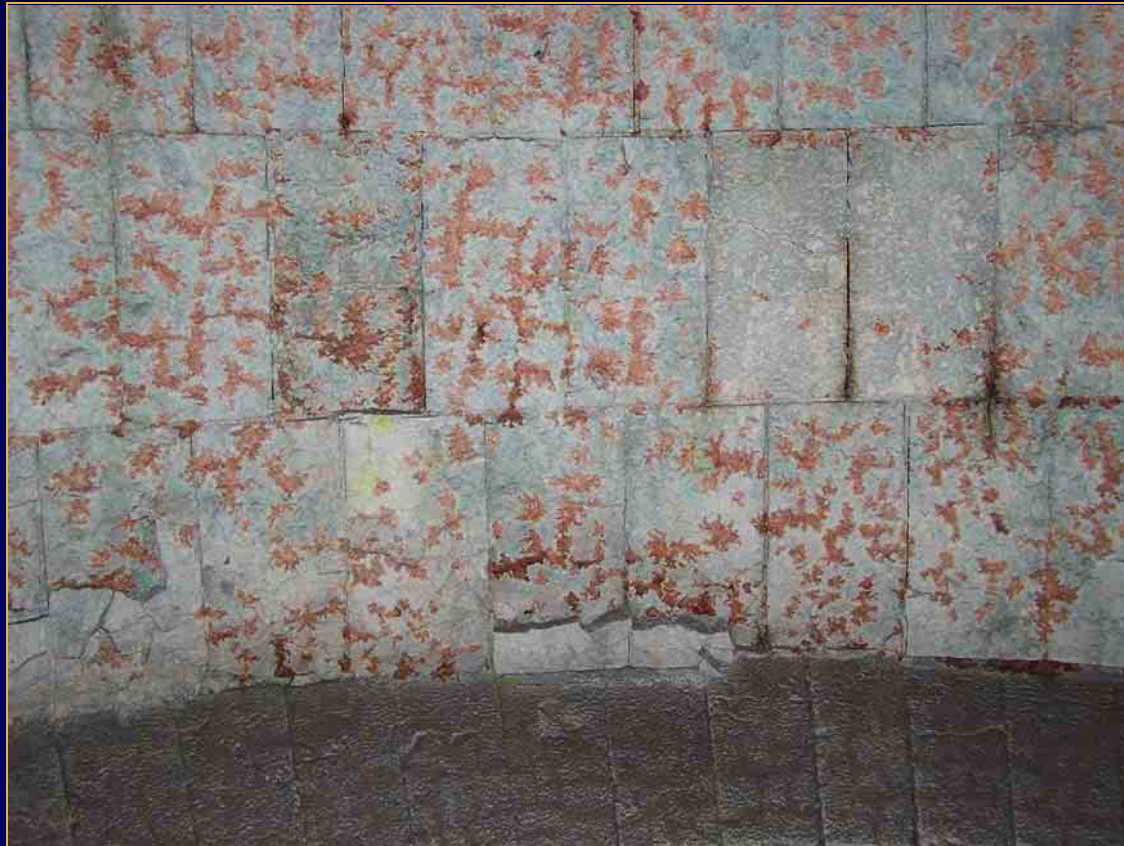
Refractory lining near bottom of barrel portion of gasifier vessel. Note red lines indicating apparent cracks on most blocks except for two in the second row (upper right).

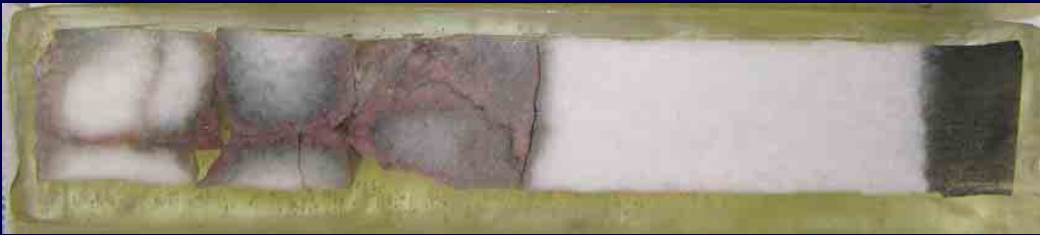
Fusion-cast alumina refractory

- ❖ The fusion-cast  $\alpha/\beta$ -alumina showed less spalling than any refractory previously used for the vessel lining
- ❖ Cracking was evident through about the first half of the fusion-cast  $\alpha/\beta$ -alumina bricks that were examined
- ❖ The fusion-cast magnesia-alumina spinel showed less cracking and penetration of sodium than the fusion-cast  $\alpha/\beta$ -alumina
- ❖ The alternate fusion-cast  $\alpha/\beta$ -alumina and the bonded magnesia-alumina bricks reacted more extensively

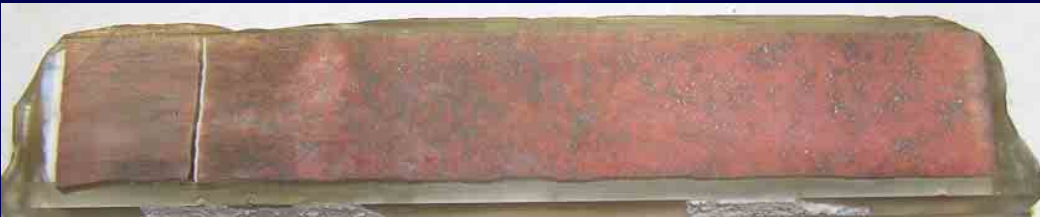
Fusion-cast magnesia-alumina refractory

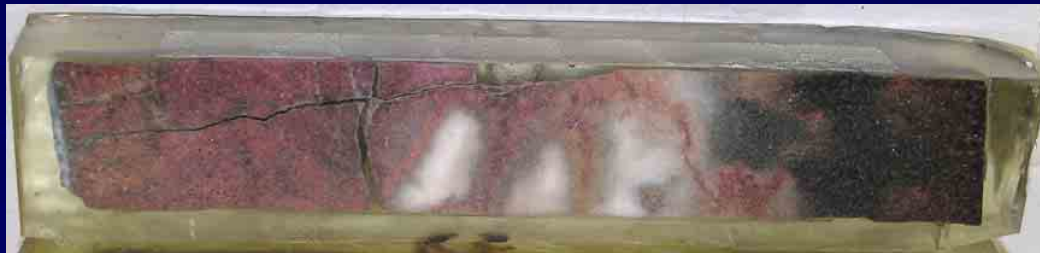
Alternate fusion cast alumina refractory

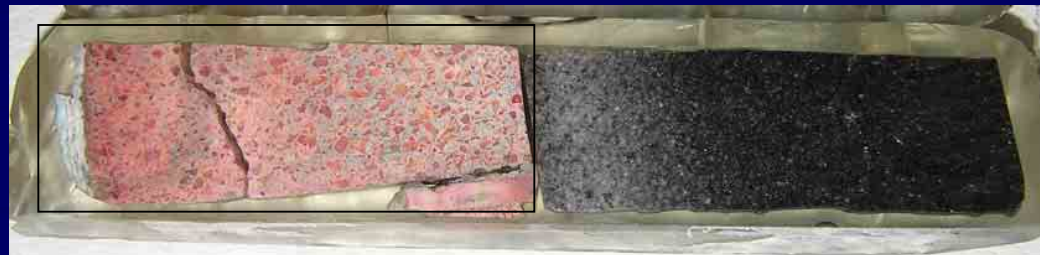
Bonded magnesia-alumina refractory (outlined at left)

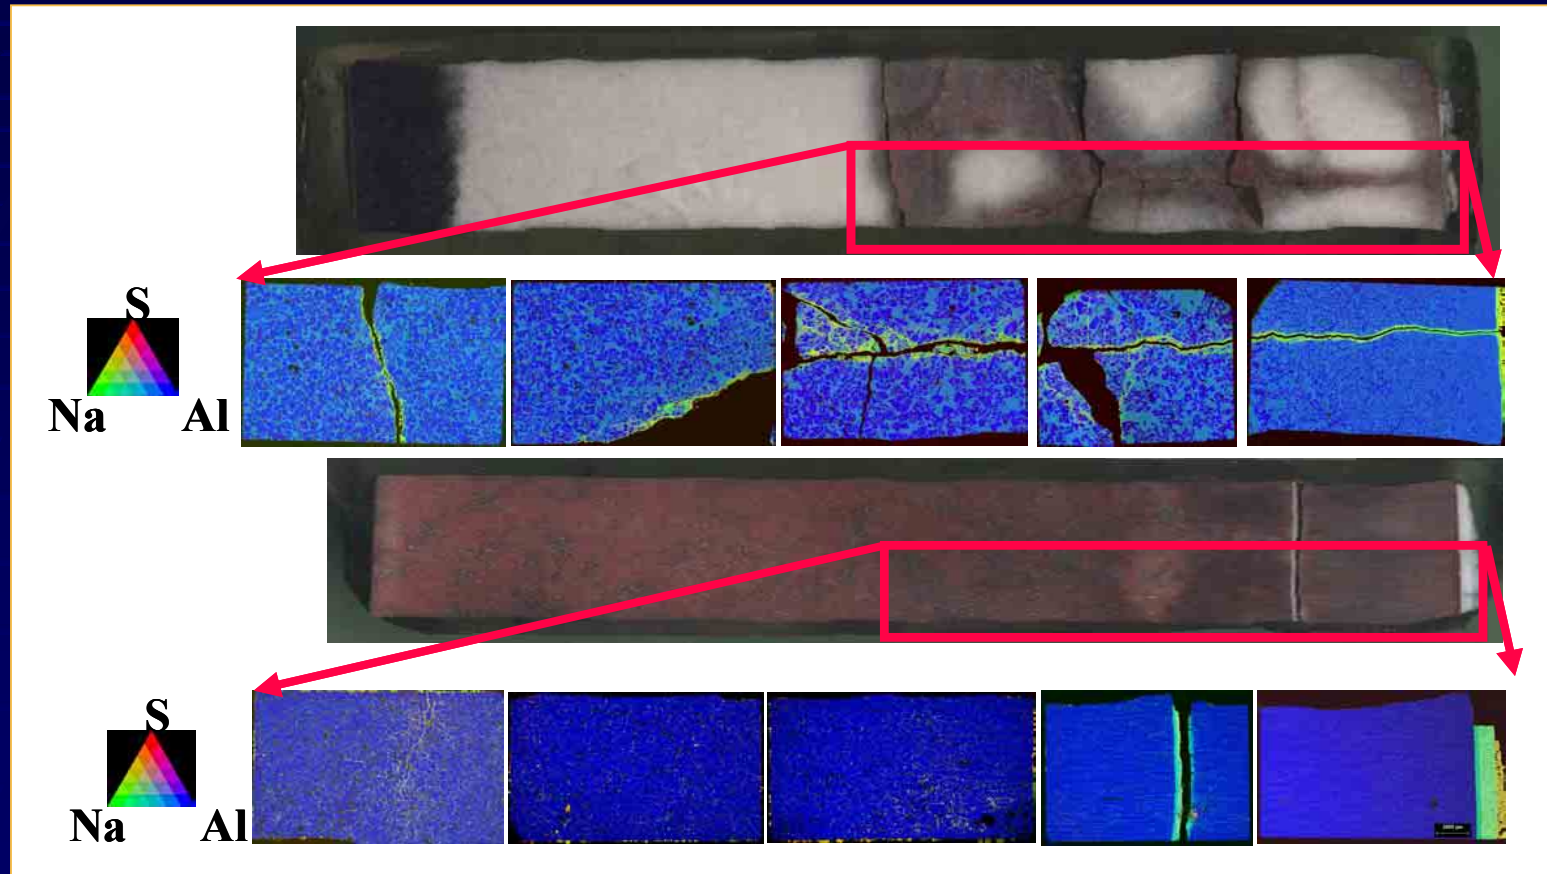
Overlaid elemental maps of sodium, sulfur and aluminum for the fusion  $\alpha/\beta$  refractory (upper) and a fusion-cast magnesia-alumina spinel (lower).

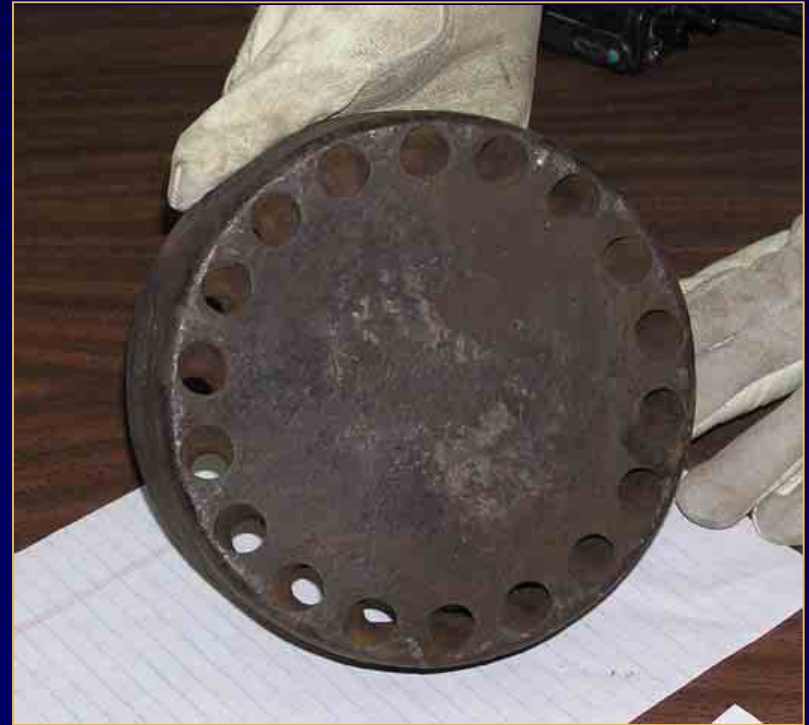
Delivery end of nozzle showing wastage

Inserts of various wear-resistant ceramic and metallic materials are being fabricated and will be tested in this system
